NEED ASSESSMENT STUDY FOR RESTORATION OF A CULTURAL HERITAGE SITE - JOHN HALL, GURUGRAM

A Report by

Indian Institute of Corporate Affairs and Haryana CSR PMU

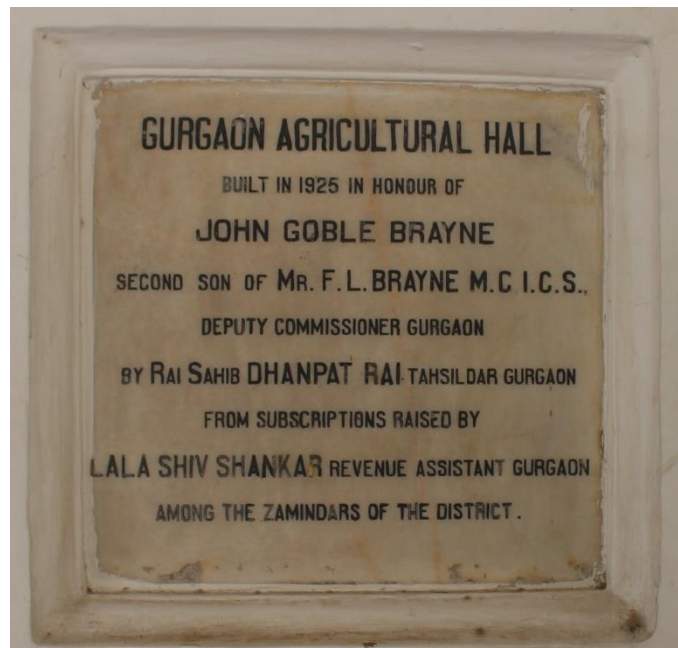
Two plaques, embedded in the masonry walls of the structure gives details of the construction of this hall. The hall was built by Rai Sahib Dhanpat Rai, Tehsildar of Gurgaon from subscriptions raised by Lala Shiv Shankar, Revenue Assistant of Gurgaon. The donations were collected from zamindars of the districts and names of some donors (those who contributed 250 rupees and above) are displayed on the second plaque.

*Image 3-1 Plaque displaying names of eminent people associated with the construction of John Hall;
Source - Project Team*

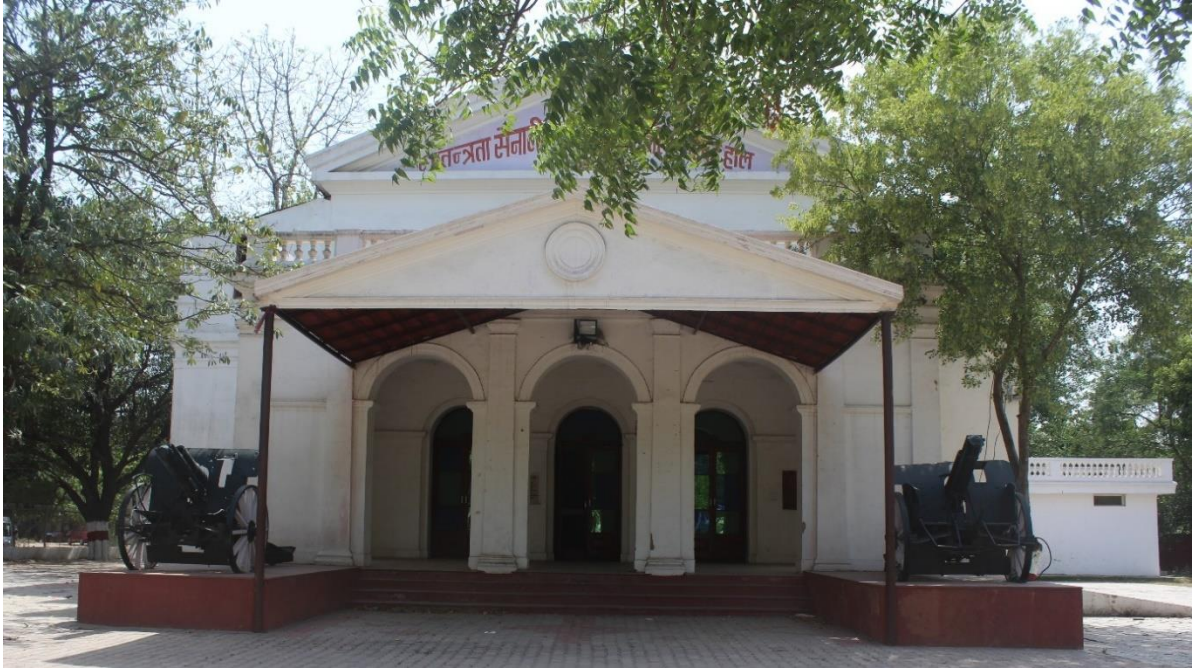
*Image 3-2 Front elevation of John Hall showing the entrance to structure from porch;
Source - Project Team*

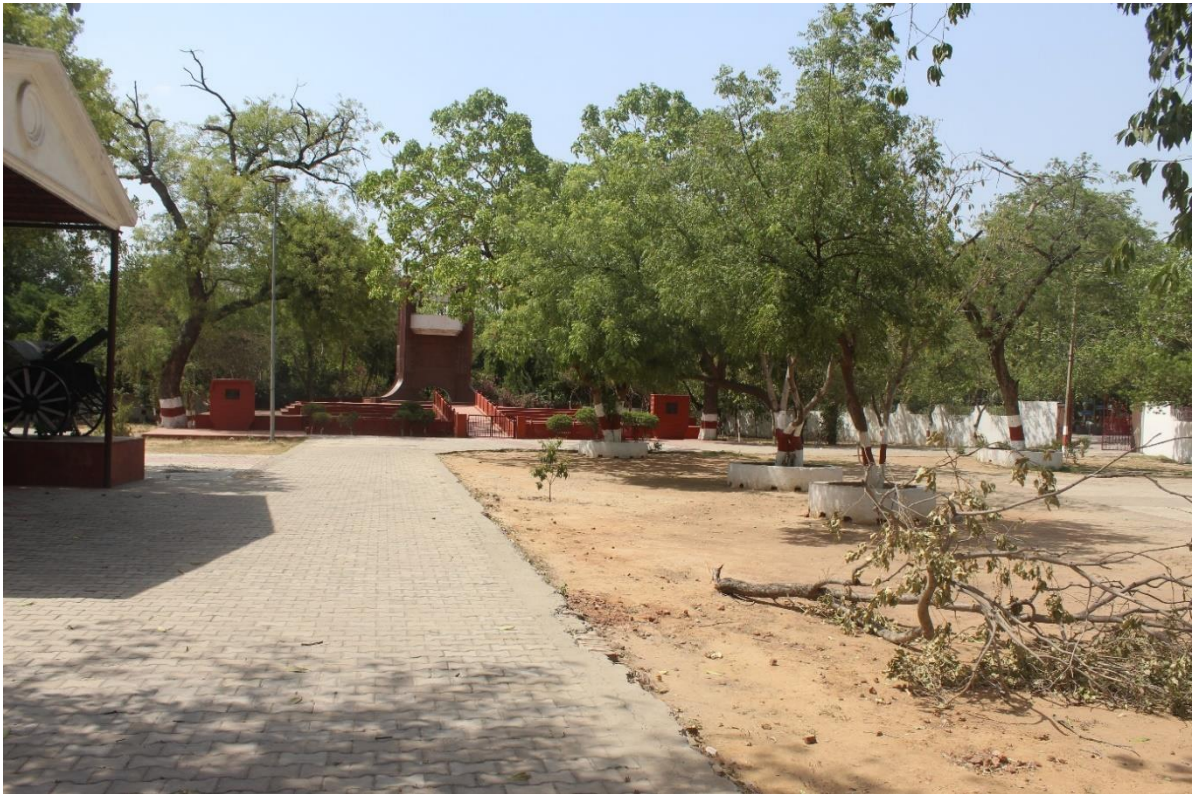
*Image 3-3 War memorial on the north-eastern corner of site;
Source - Project Team*

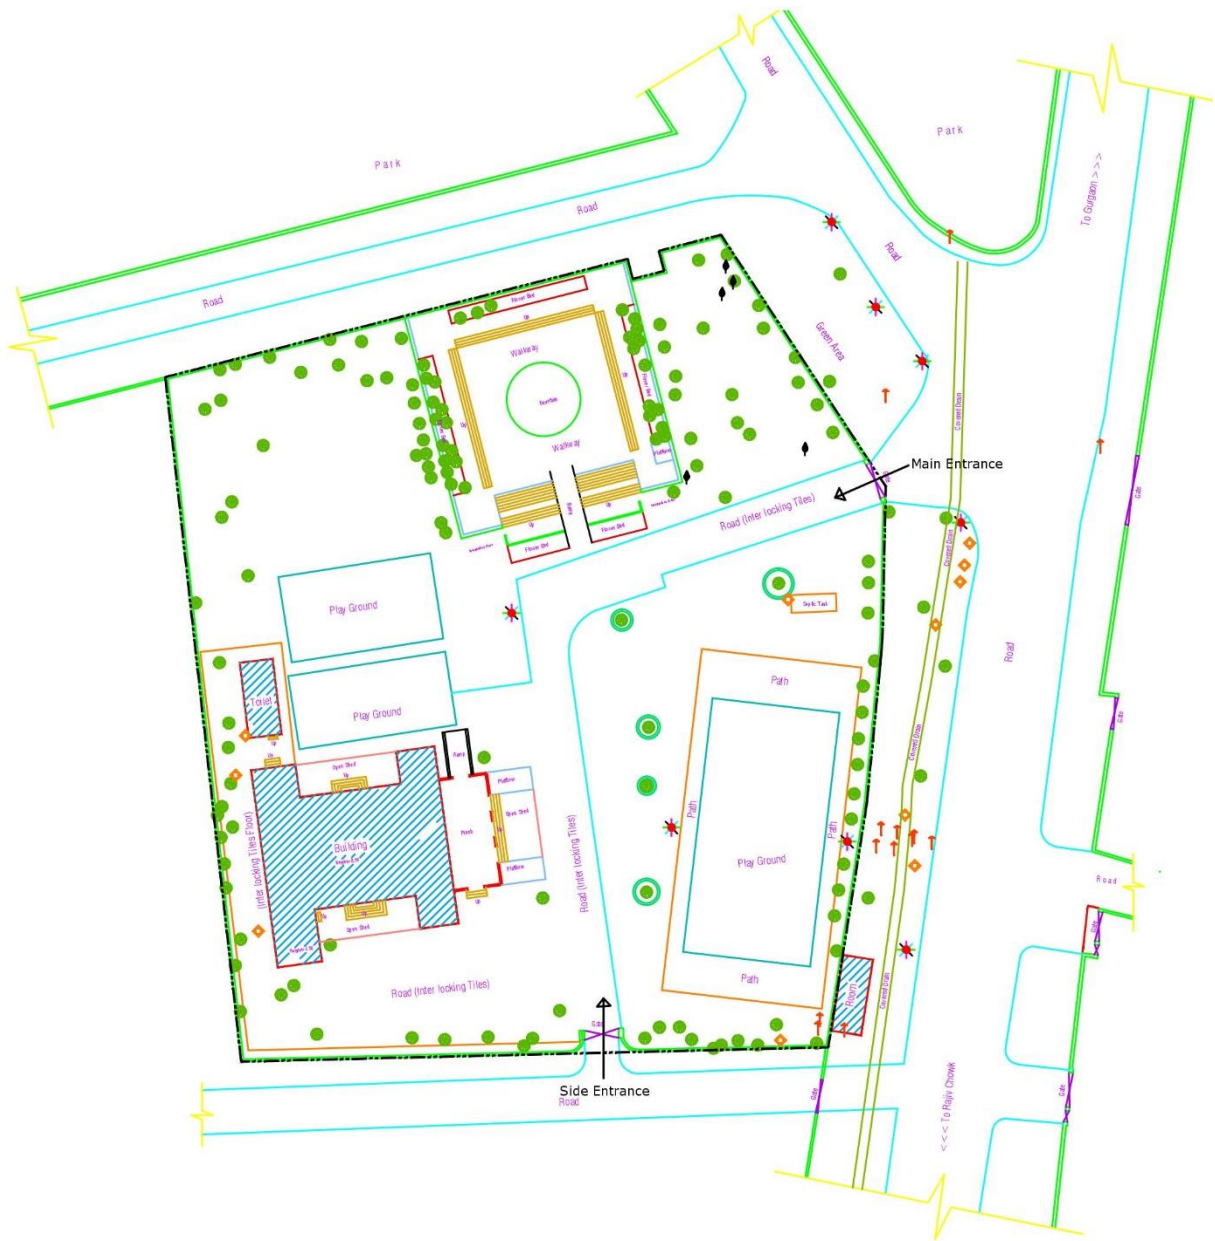
Image 3-4 Site plan showing major spaces and access routes to the site;
Source - Project Team

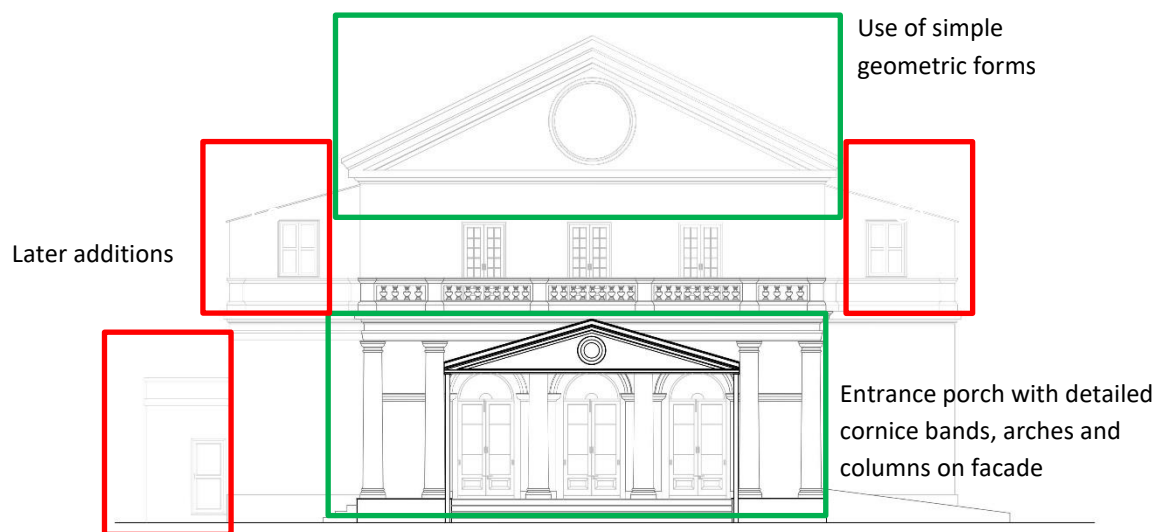
John Hall, although not entirely neoclassical in nature, does have certain elements of the architectural style which can be seen in symmetry of spaces, dramatic use of columns inside the structure and on façade of the building and in details of column and cornice bands.

Image 3-5 Front elevation of the structure showing original elements of architectural style (in green), and later additions in red; Source - Project Team

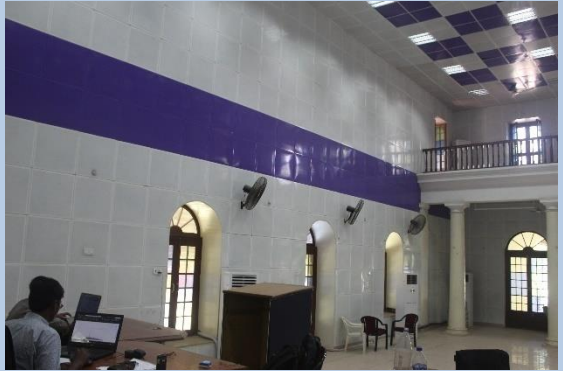
S.no.	Interventions	Issues	NB or B	Reference Drawings/Photographs
1.	In order to make the interior echo proof, sound proof panels were laid on walls and false ceiling made of same panels were also added	<p>a. This action has stripped the structure of its identity as it no longer looks like a historic building of 20th century from inside. With the technical advancement, there were a number of less evasive ways to achieve the desired result. However, if these panels are taken out, the original walls can be retained.</p> <p>b. Before carrying out this task, no documentation and photo documentation of original structure was done. As there is very less archival information available for this particular site, documentation of original structure would have been helpful in making recommendations so as how to restore it to its former glory.</p>	NB

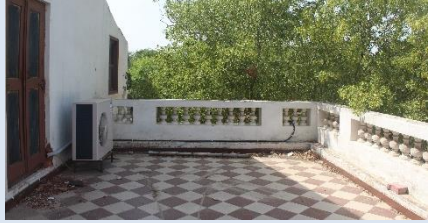
2.	Flooring of structure is completely new, modern tiles have been laid all around the structure, even on terrace	<p>a. This is the most evasive intervention carried out in this structure. No evidence of original flooring can be seen, original levels are lost which is evident at several places where <i>chaukhats</i> or door frames are buried in the flooring.</p> <p>b. Before carrying out this task, no documentation and photo documentation of original structure was done. As there is very less archival information available for this particular site, documentation of original structure would have been helpful in making recommendations so as how to restore it to its former glory.</p>	NB
